DEPARTMENT OF TRANSPORTATION**DIVISION OF ENGINEERING SERVICES**

Contract #: 04-0120F4Cty: SF/ALA Rte: 80 PM: 13.2/13.9File #: 1.28**WELDING INSPECTION REPORT****Resident Engineer:** Casey, William**Address:** 333 Burma Road**City:** Oakland, CA 94607**Report No:** WIR-029034**Date Inspected:** 28-Jan-2013**Project Name:** SAS Superstructure**OSM Arrival Time:** 700**Prime Contractor:** American Bridge/Fluor Enterprises, a JV**OSM Departure Time:** 1730**Contractor:** American Bridge/Fluor Enterprises, a JV**Location:** Job Site**CWI Name:** As noted below**CWI Present:** Yes No**Inspected CWI report:** Yes No N/A**Rod Oven in Use:** Yes No N/A**Electrode to specification:** Yes No N/A**Weld Procedures Followed:** Yes No N/A**Qualified Welders:** Yes No N/A**Verified Joint Fit-up:** Yes No N/A**Approved Drawings:** Yes No N/A**Approved WPS:** Yes No N/A**Delayed / Cancelled:** Yes No N/A**Bridge No:** 34-0006**Component:** SAS OBG**Summary of Items Observed:**

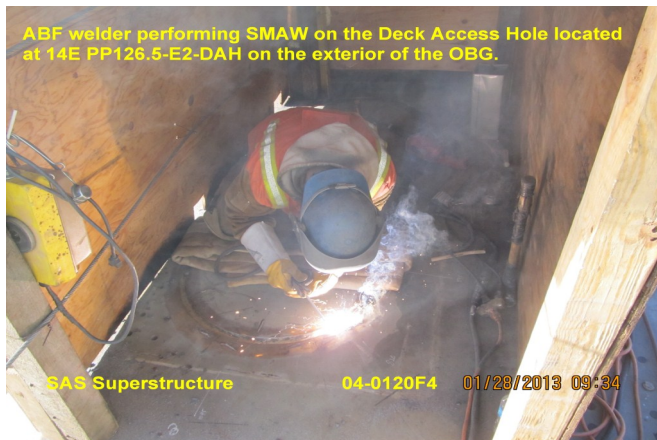
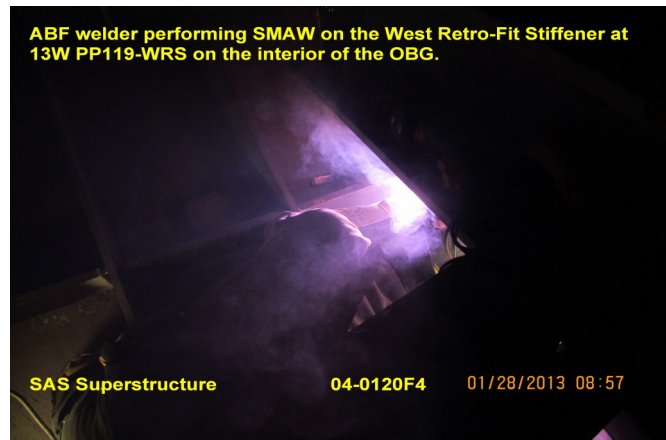
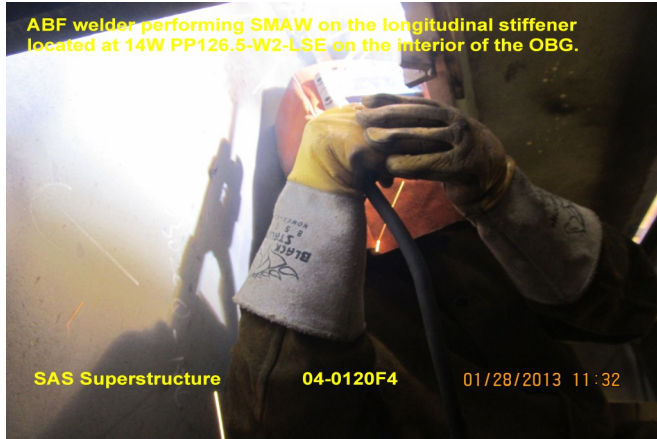
ABF welder Wai Kit Lai #2953 was observed performing SMAW welding on the Deck Access Hole at 14E PP126.5-E2-DAH. The welder was observed utilizing WPS ABF-D1.5-1040C-CU for SMAW. The welder was observed preheating the welds prior to welding. Other welding parameters as inspected by the QC Inspector appeared to be in compliance with the WPS noted above.

ABF welder Richard Garcia #5892 was observed performing SMAW welding on the longitudinal stiffener of the deck access hole located at 14W PP126.5-W2-DAH-LSE. The welder was observed utilizing WPS ABF-D1.5-1012-3 for SMAW. The welder was observed preheating the welds prior to welding. Other welding parameters as inspected by the QC Inspector appeared to be in compliance with the WPS noted above.

FW Spencer welder Damien Llamas # 6645 was observed performing SMAW welding on pipe brackets to PS12 Channel at 8E PP62-E5 on the exterior of the OBG. The weld numbers were noted as 130128-01 and 02. The welder was observed utilizing WPS FWS-Fillets Murex for SMAW. The welder was observed preheating the welds prior to welding. Other welding parameters as inspected by the QC Inspector appeared to be in compliance with the WPS noted above.

ABF welder Richard Clayborn #2773 was observed performing ongoing weld repairs on 12E PP129.5-E2-DAH at y=1150mm. The dimension of the excavation was recorded as 60L/30W/6D, at y=1480mm the dimensions of the excavation was recorded as 100L/20W/10D, at y=3600mm the dimensions of the excavation was recorded as 80L/7W/15D. The welder was observed utilizing WPS ABF-WPS-D15-1004-Repair-Revision 0 for SMAW. The welder was observed preheating the welds prior to Carbon Arc Gouging and welding. Other welding parameters as inspected by the QC Inspector appeared to be in compliance with the WPS noted above.

ABF welder Mike Jimenez #4671 was observed performing SMAW welding on the west retro-fit stiffener (WRS) located at 13W PP119-WRS. The welder was observed utilizing WPS ABF-D1.5-F1200A for the Partial Penetration Joint. The welder was observed preheating the welds prior to welding. Other welding parameters as inspected by the QC Inspector appeared to be in compliance with the WPS noted above.
